**PROPOSED SCOPE OF WORK**  
**Repair Building 1005 Exterior & Interior, New Post Chapel**  
**25 April 2005**

**Project Number KK00110-5J**

**Architectural Scope of Work:**

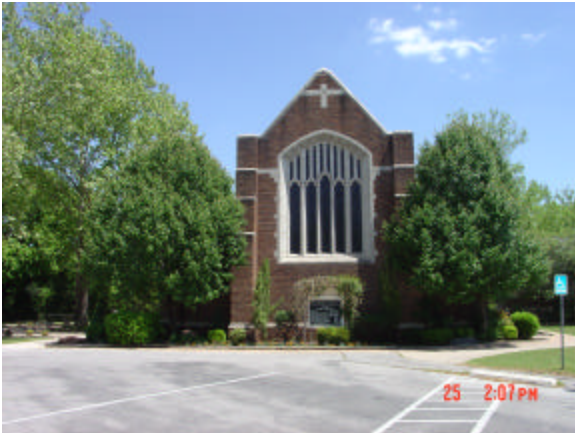
Photograph 1- West side showing two trees

1. Remove the two trees marked as photograph 1 and three overgrown shrubbery indicated on the photographs marked Photograph 2.

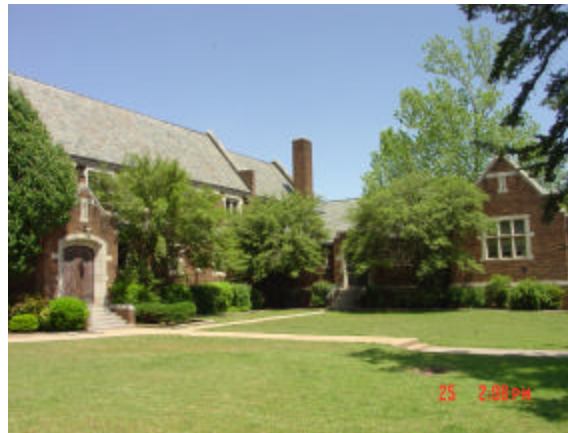
Photograph 2- Northwest side showing shrubs

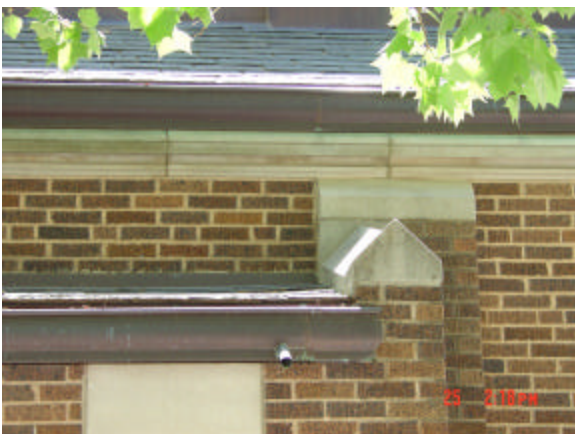
Photograph 3- North side showing gutters

2. Water test all gutters, downspouts and French drains to determine signs of clogged or defective system. Thoroughly clean out all gutters, downspouts and French drains to prevent water intrusion by backing water up on roof and overflowing around flashing. Repair any damage or defects to gutters, downspouts and French drains. Carefully examine roof over Confessionals 1A, 1B, 1C and Vestibule 1D shall be repair sufficiently to prevent water from entering walls above these areas. Examine all visible flashing for tears, damage or defects. Repair tears damage or defects in flashing. All materials and methods of repair shall be identical to and consistent with the original construction.

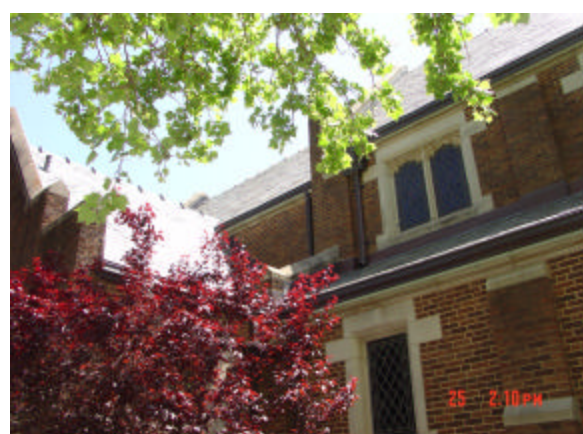
Photograph 4- North side showing upper gutters

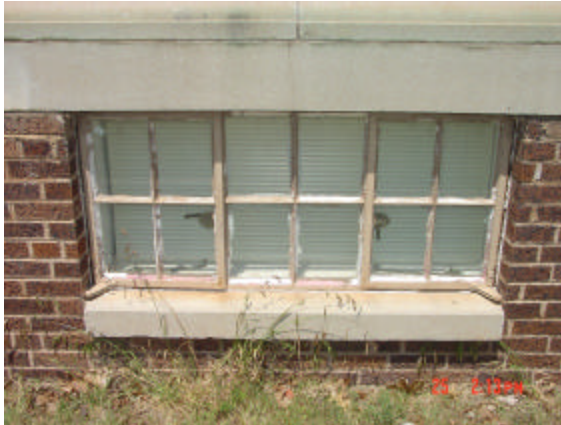
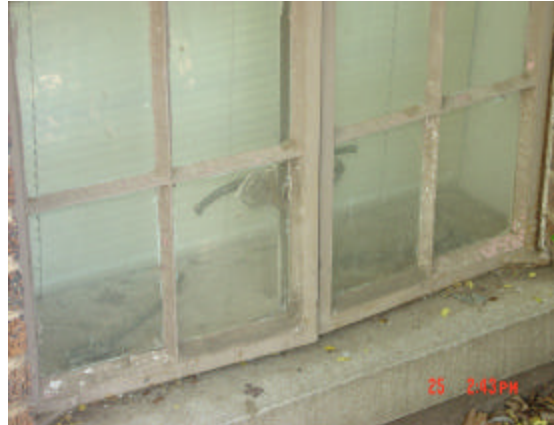
3. Maintenance of the steel casement windows shall follow the guidelines of US Department of Interior Preservation Brief Number 13, "The Repair and Thermal Upgrading of Historic Steel Windows". <http://www.cr.nps.gov/hps/tps/briefs/brief13.htm> Windows were manufactured by Hope Windows Inc, 84 Hopkins Ave., Jamestown, NY 14702-0580, (716) 665-5124. Thoroughly remove sealant from around all steel windows, between steel window frame and surrounding masonry. Windows

Photograph 6- South side steel casement windows    Photograph 7- west side steel casement windows

are in basically sound condition. The following steps are to be taken: 1) repair all window levers and mechanisms as required to place all windows in working order, using original parts from the manufacturer, 2) removal of light rust, flaking and excessive paint; 3) priming of exposed metal with a rust-inhibiting primer; 4) replacement of cracked or broken glass and glazing compound; 5) replace missing screws or fasteners; 6) cleaning and lubrication of hinges; 7) repainting of all steel sections with two coats of finish paint compatible with the primer (match existing color); 8) caulking the masonry surrounds with a high quality elastomeric caulk equal to Sonneborn Sonolastic tinted to match; and repair/paint the plaster in the interior window surrounds. (Note: Paint on steel windows may contain lead base paint. Old caulking around windows may contain asbestos.)

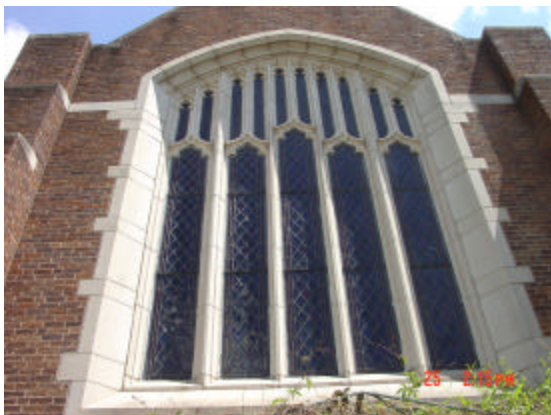
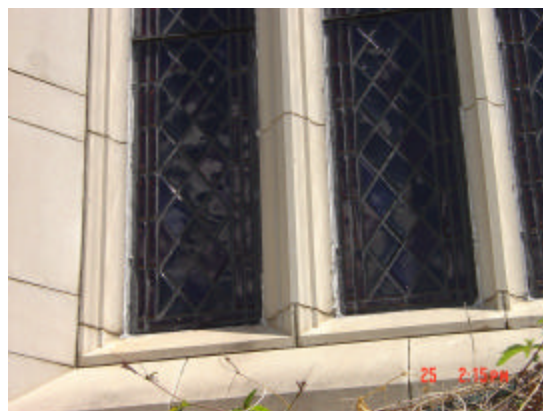
Photograph 8- West side "Dalle de Verre" windows    Photograph 9- West side "Dalle de Verre" close-up

- Maintenance of the stained glass shall follow the guidelines of US Department of Interior Preservation Brief 33, "The Preservation and Repair of Historic Stained and Leaded Glass". <http://www.cr.nps.gov/hps/tps/briefs/brief33.htm> Stained glass windows are of a relatively contemporary manufacture with a black epoxy matrix (process known as "Dalle de Verre") rather than lead or other metal and were installed in 1976. Windows are very sound structurally but are leaking around the perimeter of the window between the windows and the surrounding cast stone. Employ a stained glass expert recognized by SHPO as an expert in their field to evaluate condition of panels and surrounding seal. Carefully clean the inside and outside of the windows using water and non-ionic detergent. Final rinse the glass with water. Sealants (e.g., putties, caulks, and silicones) are used to seal the panel against the sash, and to seal any open joints around the window frame. Carefully inspect the perimeter of the panels, looking for holes and gaps in sealant. Seal holes with a sealant compatible in color and composition to the surrounding sealant. Do not remove the existing sealant and replace. Repair the existing sealant bead in place.

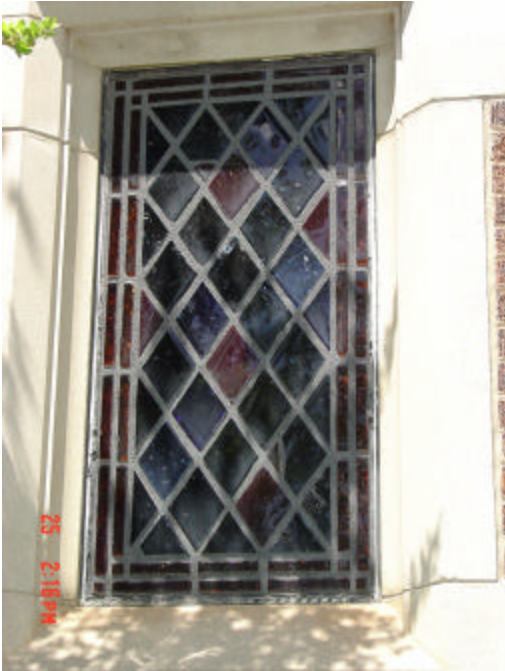
Photograph 10- South side "Dalle de Verre" windows

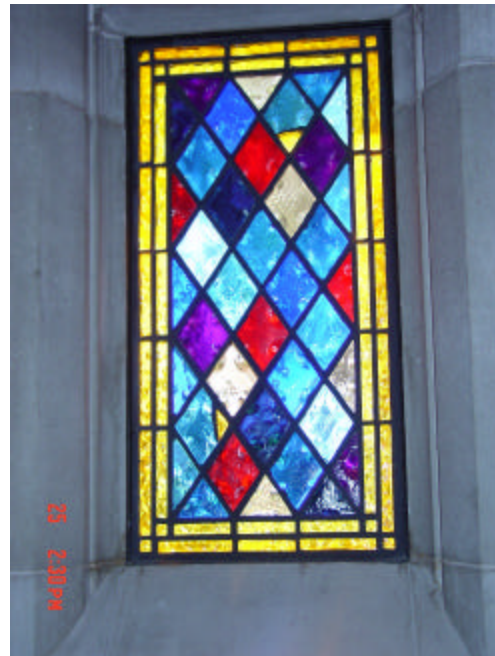
Photograph 11- South side "Dalle de Verre" interior

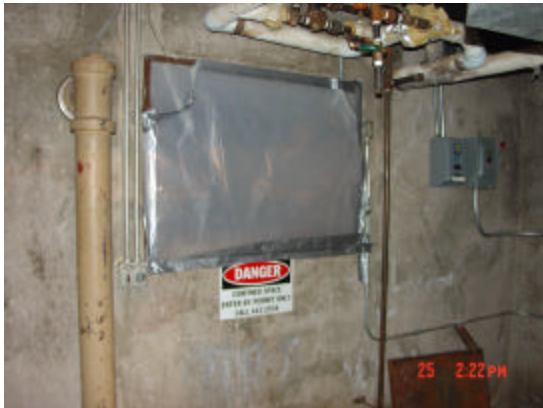
7. The crawl space area marked B8 on the attached plan (B8) has pipe insulation that has tested as friable asbestos. Insulation is deteriorated. "Hatch A" into the crawl space is missing and has been replaced with a temporary barrier. Construct and install a new lockable hatch cover at "Hatch A" equal in materials, design and construction to the hatch cover currently installed at "Hatch B". Remove asbestos pipe insulation from pipes and in soil in crawl space. Re-insulate pipes with fiberglass insulation.

Picture 18- Hatch A to crawl space B8

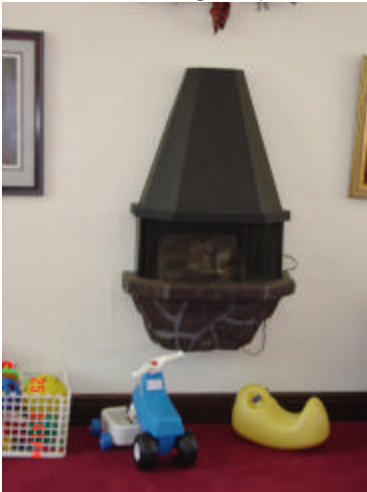
Picture 37- Remove "Fireplace"

18. Nursery 12: Remove the existing simulated fireplace and repair wall. Paint all walls and ceilings. Remove existing carpet and replace with new.
